Manhole Inspection Summary

Manhole # S51EE_002MH

Insp Date: **6/27/08 10:11 AM**

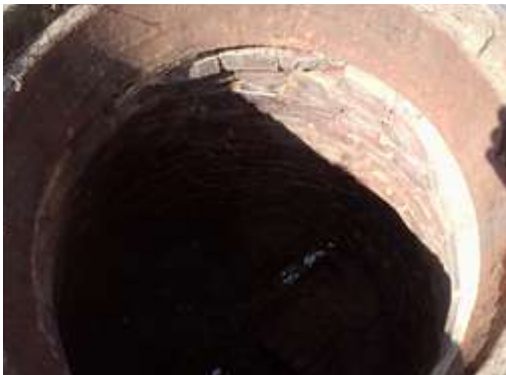
Defect 1

Condition: ☐ Sound ☐ Cracked ☐ Root Intrusion ☒ **Loose Brick** ☐ Deteriorated

Infiltration: ☐ None ☐ Joint ☐ Cracks ☒ **Mortar** ☐ Roots ☐ Wall

loose brick

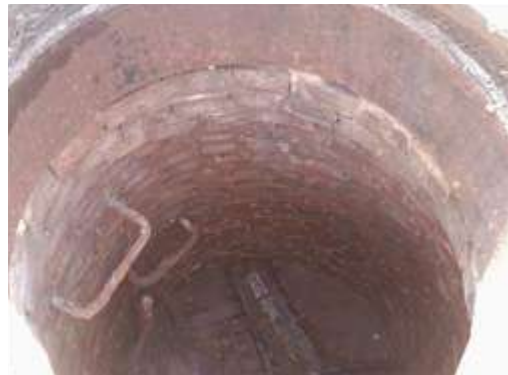
Defect 2

frame leaks

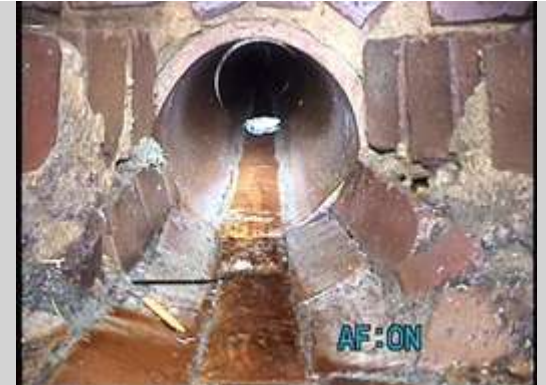
12 O'Clock Outflow

8 in. Circular Gravity Sewer
Pipe Out @ 12 O'Clock

Pipe Height: **8.4** (in.) Rod and Bar (Angled)
Pipe Material: **Clay** ☐ Pipe Lined
Invert Depth: **8.05** (ft.) Flow Characteristics: **Fast**
Deposits: ☒ None ☐ Mud ☐ Sludge ☐ Debris ☐ Grease
Silt Depth: (in.) Deposits Extent:
Infiltration: **None** Pipe Seal Cond: **Sound**

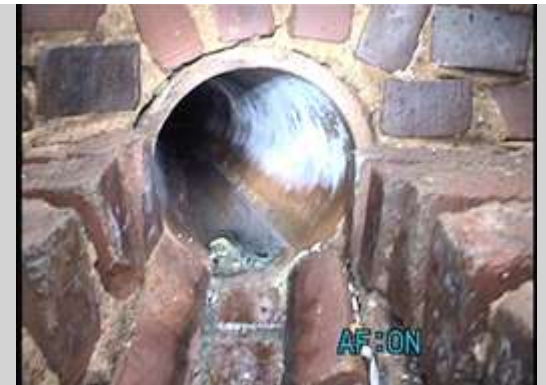
3 O'Clock Inflow

8 in. Circular Gravity Sewer
Pipe In @ 3 O'Clock

Pipe Height: **8.4** (in.) Rod and Bar (Angled)
Pipe Material: **Clay** ☐ Pipe Lined
Invert Depth: **7.45** (ft.) Flow Characteristics: **Fast**
Deposits: ☒ None ☐ Mud ☐ Sludge ☐ Debris ☐ Grease
Silt Depth: (in.) Deposits Extent:
Infiltration: **None** Pipe Seal Cond: **Sound**

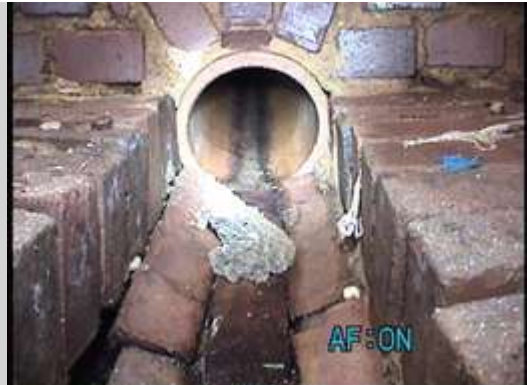
6 O'Clock Inflow

Pipe In @ 6 O'Clock

Pipe Height: **8.4** (in.) Rod and Bar (Angled)

Infiltration: **None**

Pipe Seal Cond: **Sound**

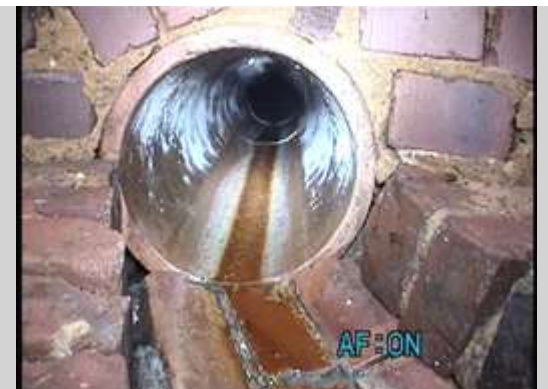
9 O'Clock Inflow

Pipe In @ 9 O'Clock

Pipe Height: **8.4** (in.) Rod and Bar (Angled)

Infiltration: **None**

Pipe Seal Cond: **Sound**
